PROJECT: Rehabilitate the Ranger Operations Building

LOCATION: South Rim, Grand Canyon National Park, Arizona

ROLE: Project Manager for Historic Structure Report, Schematic Design, Construction Documents, and Rehabilitation Construction.

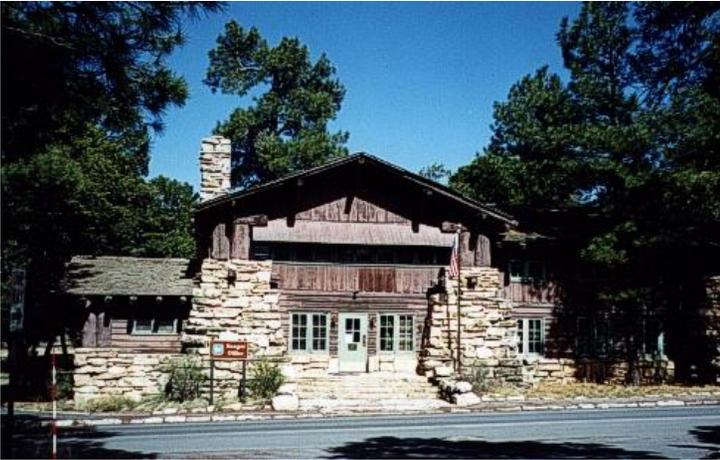
West elevation prior start of project. 1938 restroom addition visible at left.

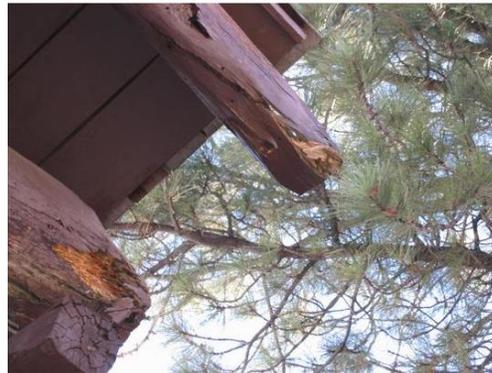
Log rafter tail condition prior to project.
